TRUSS ROD REPAIR: EXTENSIVE CARE UNIT

By Pat DiBurro

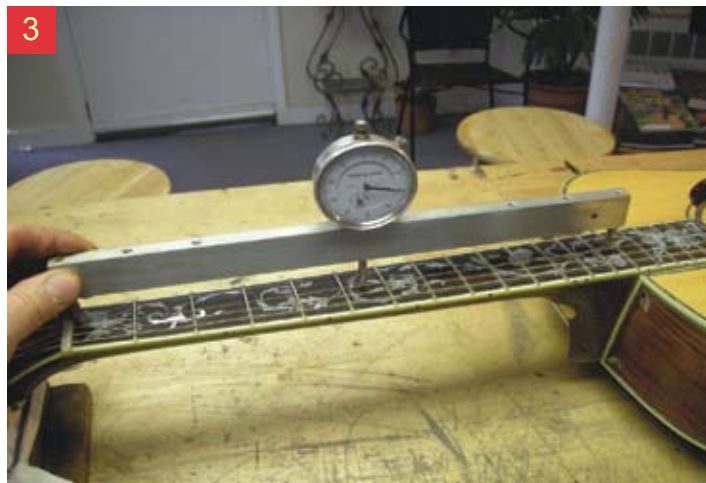
EVALUATION: Before I began an evaluation of it's playability I needed a few minutes to soak in the detail of ornamentation that seemed to envelop every angle. Within the boundaries of the ivoroid trimmed fingerboard were finely cut and engraved pearl inlay pieces depicting pixies and other magical imagery. A nude figure dominated the peghead with the maker's name set above it, and engraved pearl machine buttons peeking out the edges of the headplate. The neck was built from two fiddleback lengths of maple sandwiching a sliver of mahogany. The heel was relief carved in a floral design, with an ivory moon faced caricature set into the center. Wow!! The body was a bit toned down. Abalone trimmed edging similar to the C.F. Martin Style 45, with just an extra zing of leaf inlays. **Photo 2**

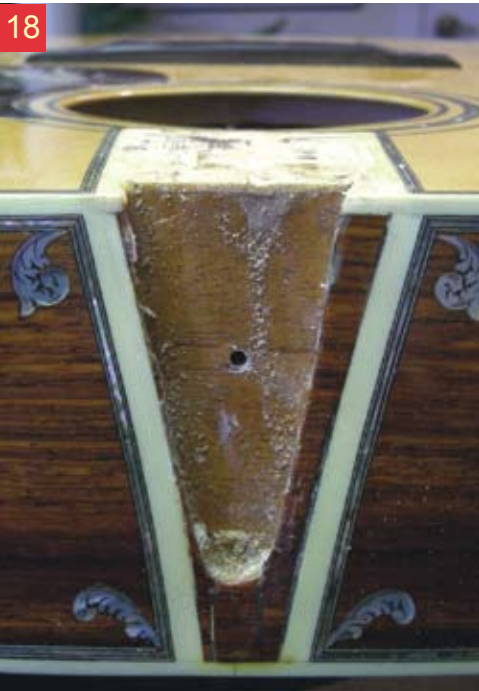
deadline approaching the neck angle was cut, dovetail fitted and pressed back in place. There was a curious offset to the neck dovetail and heel block. **Photos 17 & 18.** I'm not sure what happened here but everything lined up nicely with even lines on either side of the heel and fingerboard extension so I didn't sweat it. I was anxious the next day to pull the clamps off the neck and measure the neck under tension. The neck was still fretless as I strung it up with a set of light gauge strings. The neck relief gauge just prior to stringing measured a very comforting .004" of back bow and now with the Greven tuned to pitch the neck pulled forward to .009" for a total movement of .013". The owner in addition to his request of a nonadjustable rod had one more item on his wish list, .004" of relief plus or minus a .001". The cold winter showed no signs of letting up with single digit temps. as I turned the calendar on March. I had a full shop of dried out guitars so I put the Greven on a shelf still under tension for a few weeks. We had a warm up in mid-March and I started getting nervous about the deadline on the Greven. By late march it was once again back on the bench and the ice on the pond near my house was fading fast. All that remained was the installation of the frets and they were the key to getting this neck to the desired relief. Out of necessity to straighten their necks, the C.F. Martin Company sells their standard fret crown with 7 different tang thicknesses from .0185 to .0245. By carefully measuring a thickness of a fret slot and selecting a fret of a thicker number the fretboard can be straight or even back bowed. Compression fretting is a common term for this method and it's aptly named. The area of concern is frets 3 through 10. Above and below that area the frets do not have as much affect on the neck curvature. The fret slots on the Greven measured a pretty uniform .021" so I decided to hammer in some big boys, .0245". I tapped in the seven frets in positions 3 though 10, made sure they were well seated and strung it up again. The relief gauge read .005", good enough for me. I went back to frets 1 and 2 using the same .0245" fret then thinned out to .0225 for the remaining frets to make it easier to set them. I've purposely neglected to include completion pictures because it appears now as it did in **photo1** except for the bow. I had to look pretty hard for any sign of remaining ice on the Squamscott River. The "bob houses" had been pulled off the river a few weeks back. I called the owner with the news his guitar was ready to go. One project completed on time while the clock spins fast on two dozen more. □
