TRUSS ROD REPAIR: EXTENSIVE CARE UNIT

By Pat DiBurro

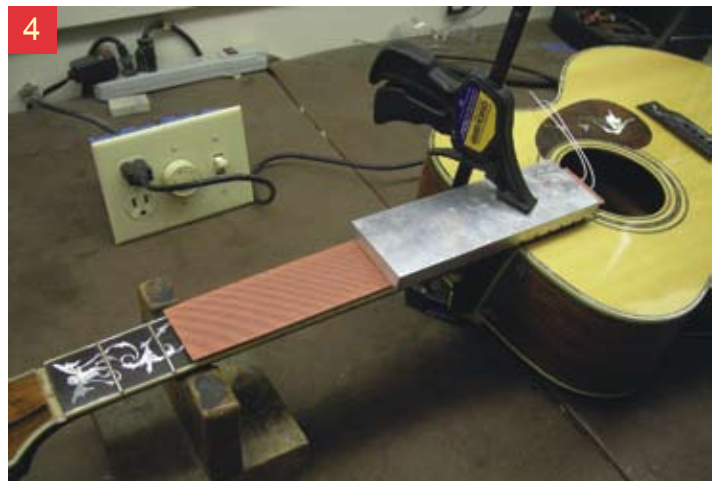
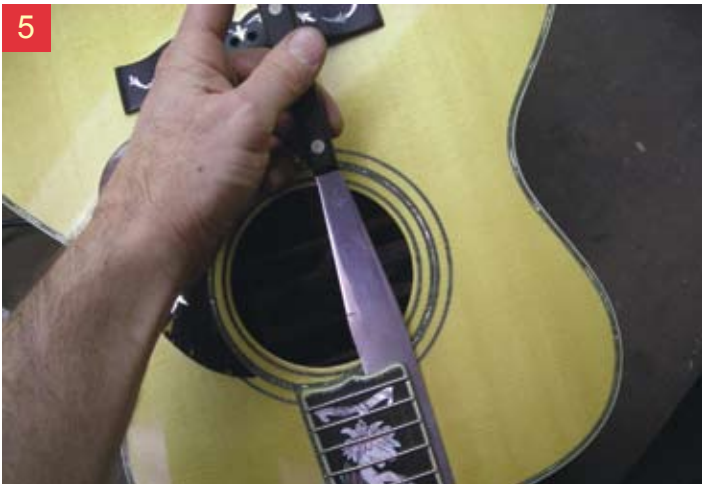
I reopened the repair shop after a two week holiday break and was eager to start on the Greven. I'd shoveled the snow from the sidewalk many times that winter and ice was just starting to build on the Squamscott River. First step on the Greven project would be to heat and pry off the fingerboard. I wanted to know what was under that ebony so I could formulate a plan. If a fingerboard needs to be removed with the intent of reinstalling it again then realignment is critical. Fortunately it's pretty easy to relocate the original position. I pulled the 1st and 12th frets out and drilled a 1/16" hole through the fret slot into the maple neck about, a 1/8" depth. The holes are diagonal with one under the 2nd string and the other under the 5th. Just prior to the reinstallation of the fingerboard a couple of nylon pins are inserted into the neck. These locating pins assure correct position and the nylon can be sliced with a fret saw prior to refretting. Dyed epoxy is the predominant method for setting pearl inlay. My concerns were applying enough heat to soften the neck/fingerboard joint without overheating the epoxy, which could lift the pearl. Perhaps the builder used hide glue or aliphatic resin, and not epoxy to secure the fingerboard. Will the pearl act as an insulator preventing the heat from traveling down to the glue joint? I wasn't sure but it crossed my mind as I laid a Benchmark silicone heating blanket on the fretboard surface. These blankets can be plugged directly into a 120 volt outlet and will vaporize pearloid inlays in seconds. I was heating the fingerboard extension of an older Gibson flattop years ago with a heating blanket and heard an unusual sound, vvvvvssssstttt, coming from the guitar. At the same time a noxious cloud of smoke trailed upward from the fingerboard. Now I pull the celluloid inlays as a precaution. Some luthier supply companies offer a control unit for silicone heating blankets and I wouldn't use a heater without one. I fabricated a controller myself with a timer and rheostat from Home depot. **Photo 4.** The timer has saved many instruments from overheating when the phone rang and I became distracted. I back up the controller time with a

little egg timer. The rheostat is the key to the whole system and it takes time to learn what setting works best. My advice would be to start on a low setting. I set some cauls on top of the blanket so it would maintain good contact with the fingerboard, unplugged the telephone, and waited. Six or seven minutes passed. I removed the heating blanket and pushed my spatula under the fingerboard extension. It sliced the glue joint with a familiar resistance and release. I pulled the spatula out and the steel edge had traces of aliphatic resin. Ok, so far so good. I've always used a long spatula for bridge and fingerboard removal tapered down close to the edge. Each time I slid the thin blade into a glue joint I would pull it out and remove the glue residual with a razor blade, then go back in for another bite. **Photo 5**
